## CERTIFICATION PROGRAM

## EVALUATION TECHNIQUES

Probe Test Certification

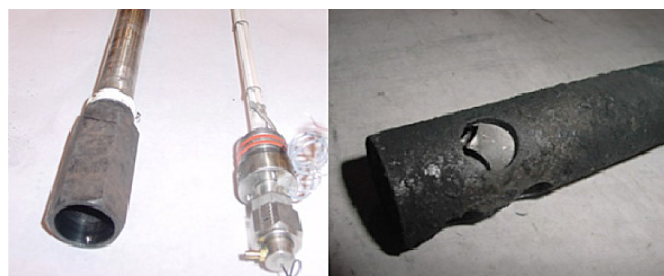
Impedance		Burnoff	
Date	5/29/14	Date	5/29/14
Time	12:42	Time	12:42
Impedance(ohm)	3.1K	Temperature	1749
Recovery Time	0:04	Measured mV	1147
		Recovery Time	0:58

PROBE MANUFACTURING AND TEST CERTIFICATE			
Tested by UPC, ISO 9001:2008 Certified			
Description	20"[500mm] NITROCARB 'K' T/C 1/4" CPI		
Serial Number	14031562201	T/C Type	K
Part Number	AA620-K-19	Furnace	2
Test Number	1404021050	Furnace Port	4
Time of Test	10:50	Reference Temp	1750°F
Initials	GSTAFF	Date of Test	04/02/14

Measurement	Standard	Tolerance	
Sensor Temp	1725 °F	1750 °F	± 25 °F	PASSED
mV Reading before impedance	84.3 mV	80.2 mV	± 5.0 mV	PASSED
Impedance	2.9 KΩ	≤ 3 KΩ		PASSED
mV Reading after impedance	84.2 mV	± 3 mV deviation		PASSED
Impedance Recovery Time	1.0 sec	≤ 2 Sec		PASSED
Ref air shut-off, leak test mV	85.4 mV	≥ -3 mV deviation		PASSED

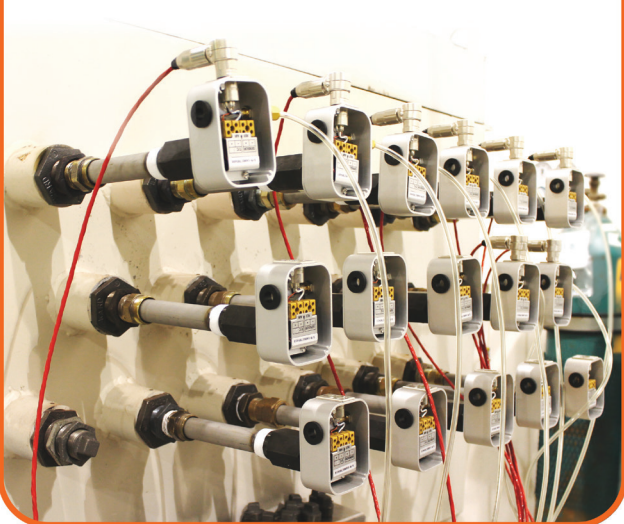
**Our large capacity test furnaces help keep turnaround times fast.**
